Capping in a Wetland

**Impacts, Benefits, and Risks
Presented By**

EPA Meeting
Managing Ecological Risks at Contaminated Sediment Sites
June 5, 2002

Soda Lake, Casper Wyoming

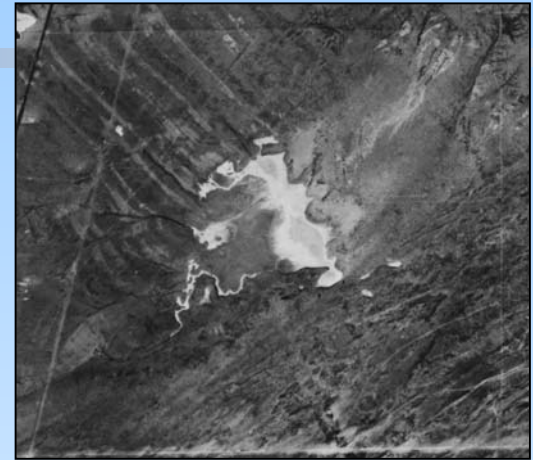
1954

- Soda Lake, a playa lake, grew to 667 acres, plus the 45-acre Inlet Basin.
- Refinery discontinued pumping of process water in 1990.
- Pumped 1.7 mgd of fresh water from the North Platte River
- Fresh water input maintains the optimal water level to preserve the wildlife and habitat.

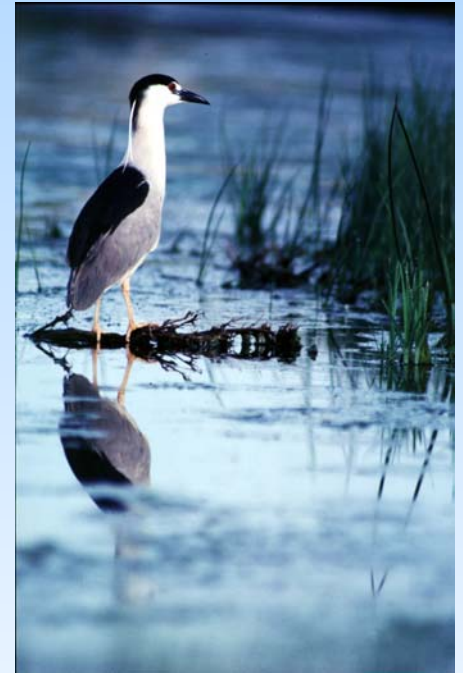
Groundwater and Surface Water

- No refinery-related organic compounds were detected in groundwater or surface water. Metals (arsenic, barium, zinc) naturally elevated.
- Discharge lake. All water migrates into the lake. Only offsite pathway is evaporation (60 monitoring wells).
- Groundwater at Soda Lake is naturally non-potable due to naturally elevated salinity, total dissolved solids, and sulfates

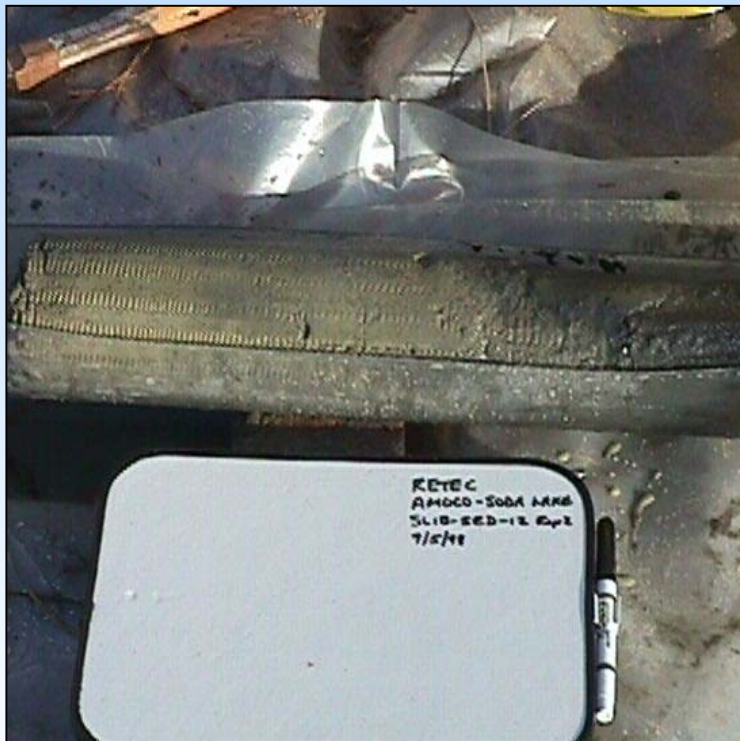
Sediment

There may be some risk to ecological receptors due to exposure to inlet basin sediments because:

- Detected chemicals of interest exceeded ecological criteria: BTEX, PAHs, metals, dioxins/furans, and some pesticides.
- The system is slowly recovering through deposition of clean sediment, but it will take up to 100 years for natural recovery to occur.
- This clean sediment has allowed freshwater vegetation to become established, where none previously existed. It supports epiphytic invertebrates.

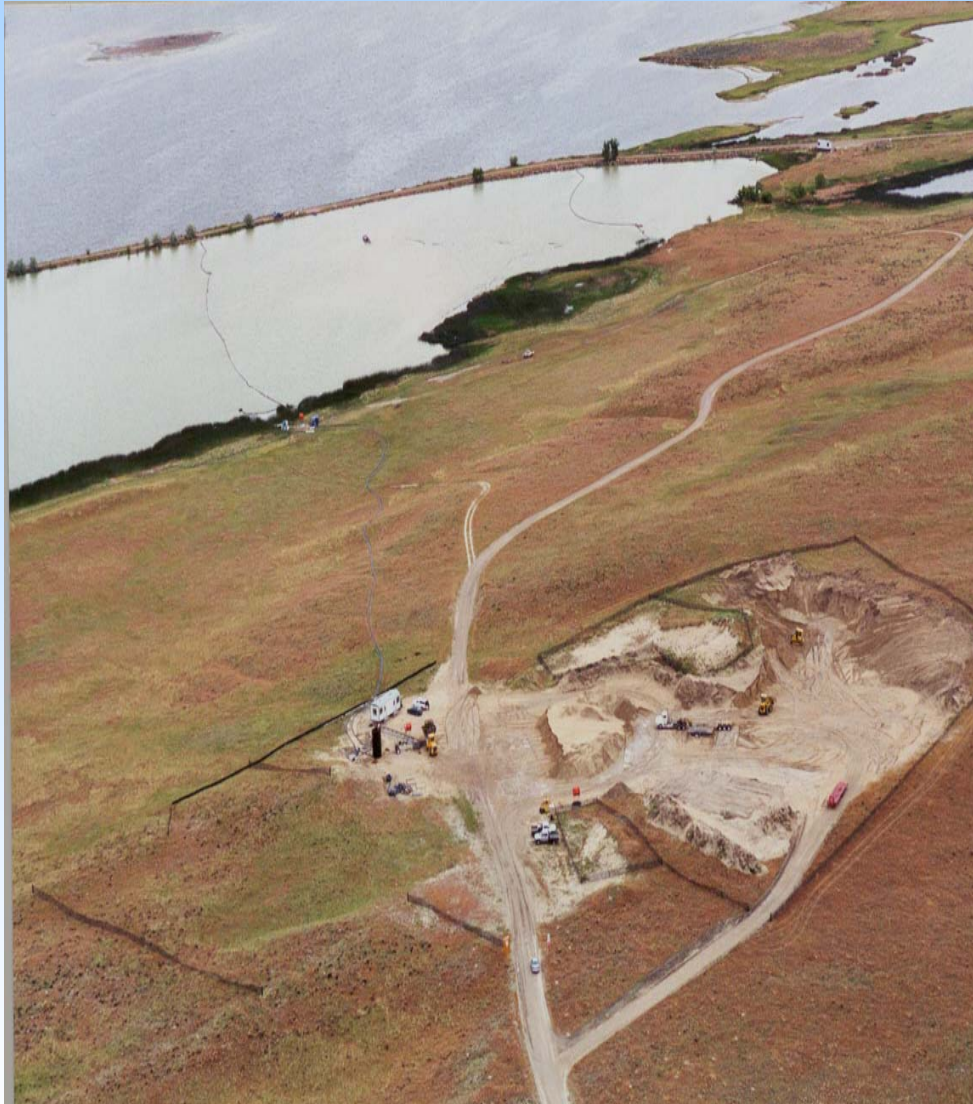
Final Design Specifications

- 6-acre cap, 950' by 260'
- Twenty-four 1.5-inch lifts
- 3 feet thick
- Spreader barge placement in deep areas
- Spray application in wetland areas
- Sand excavated onsite.

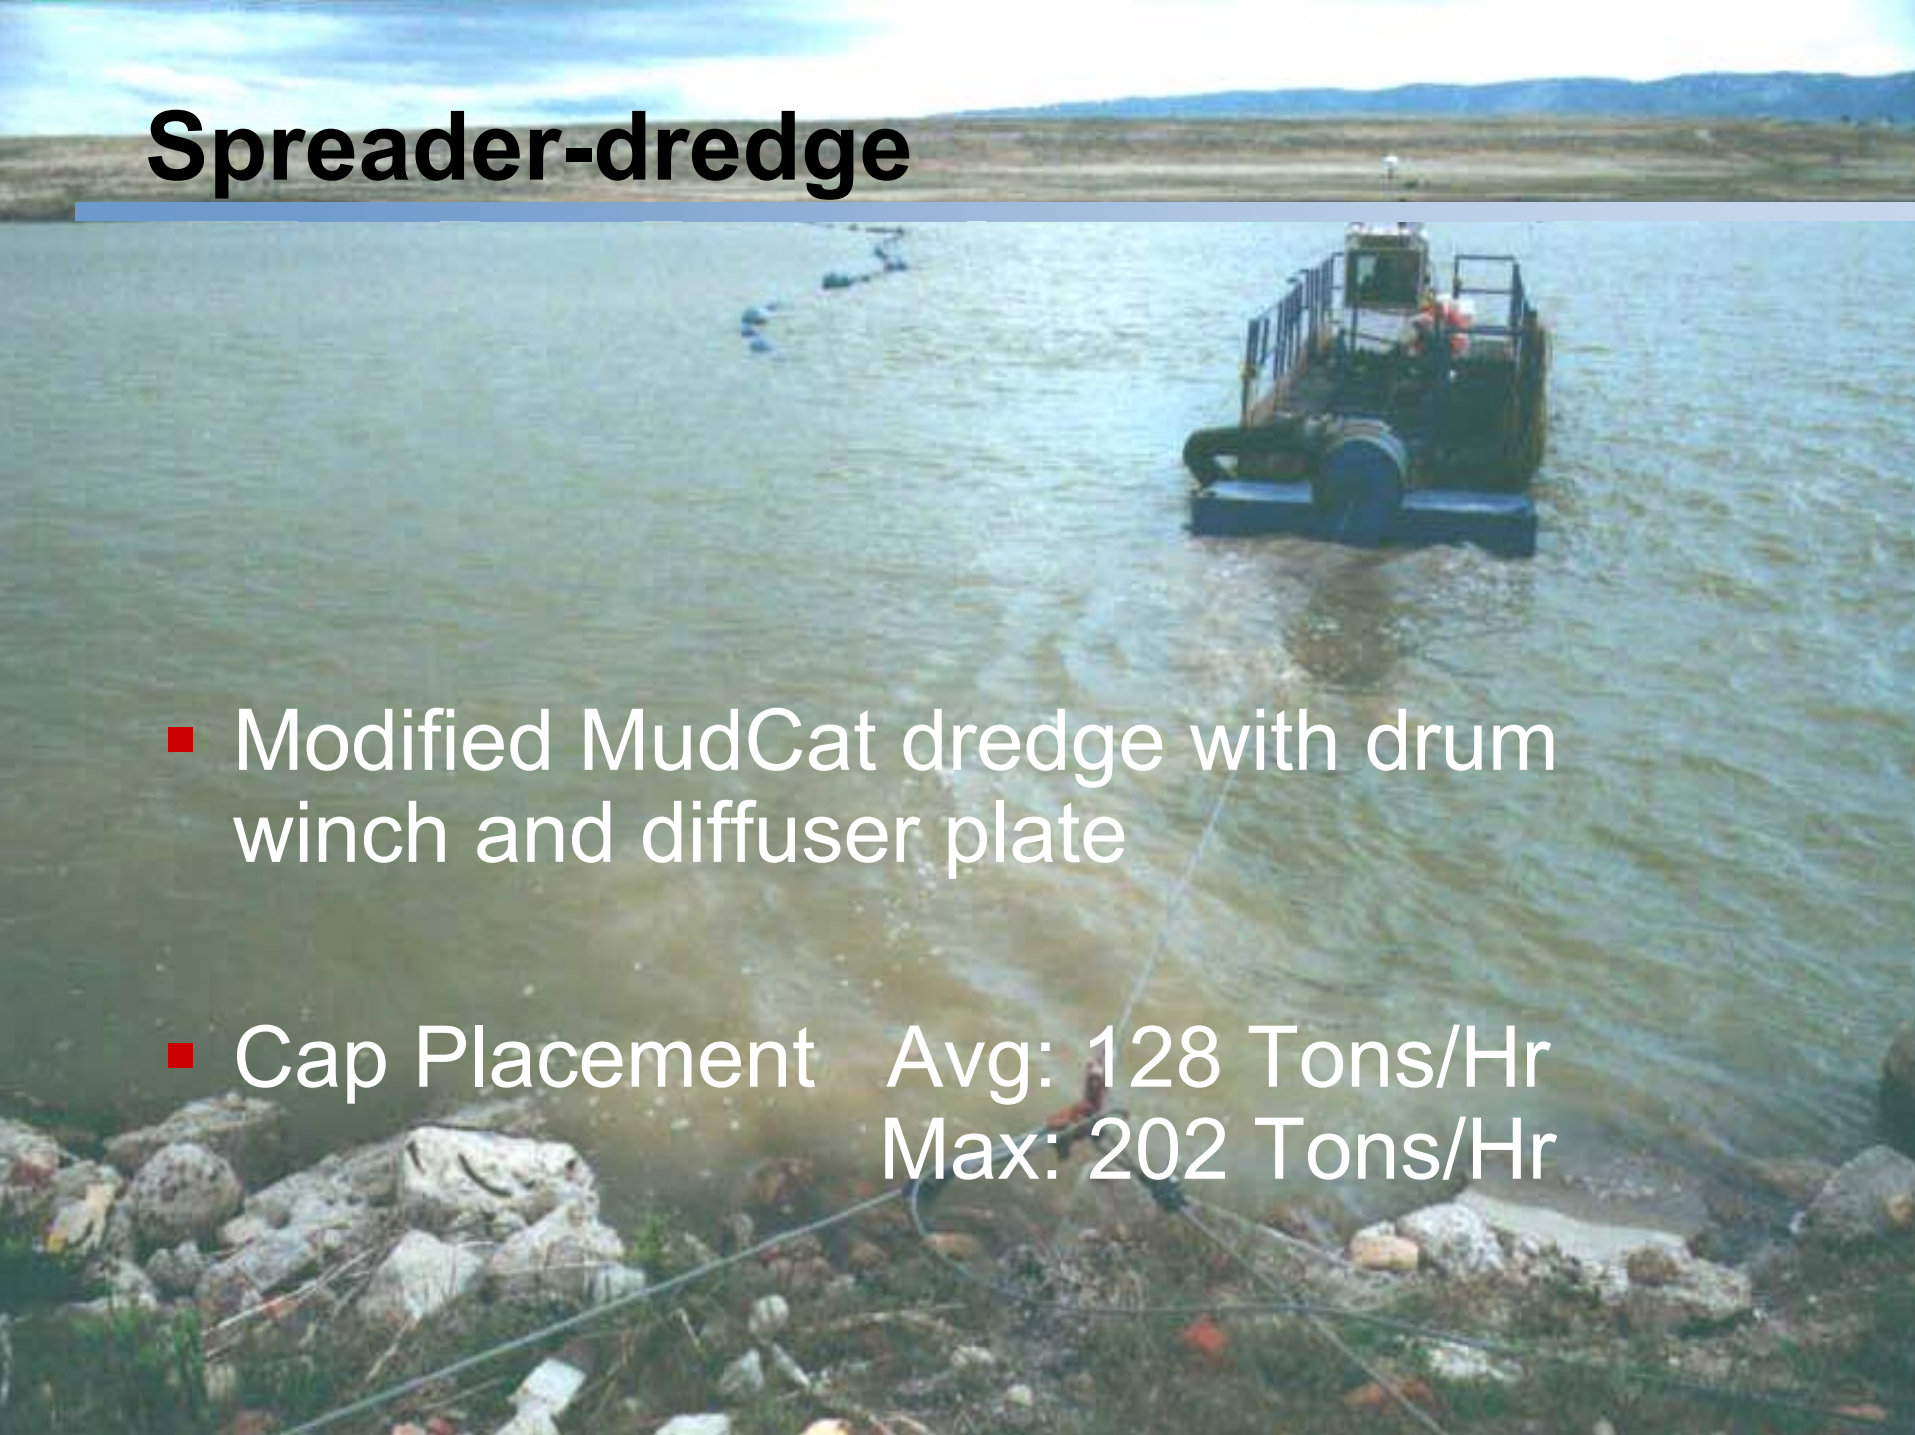
Spreader-dredge

- Modified MudCat dredge with drum winch and diffuser plate
- Cap Placement Avg: 128 Tons/Hr
 Max: 202 Tons/Hr

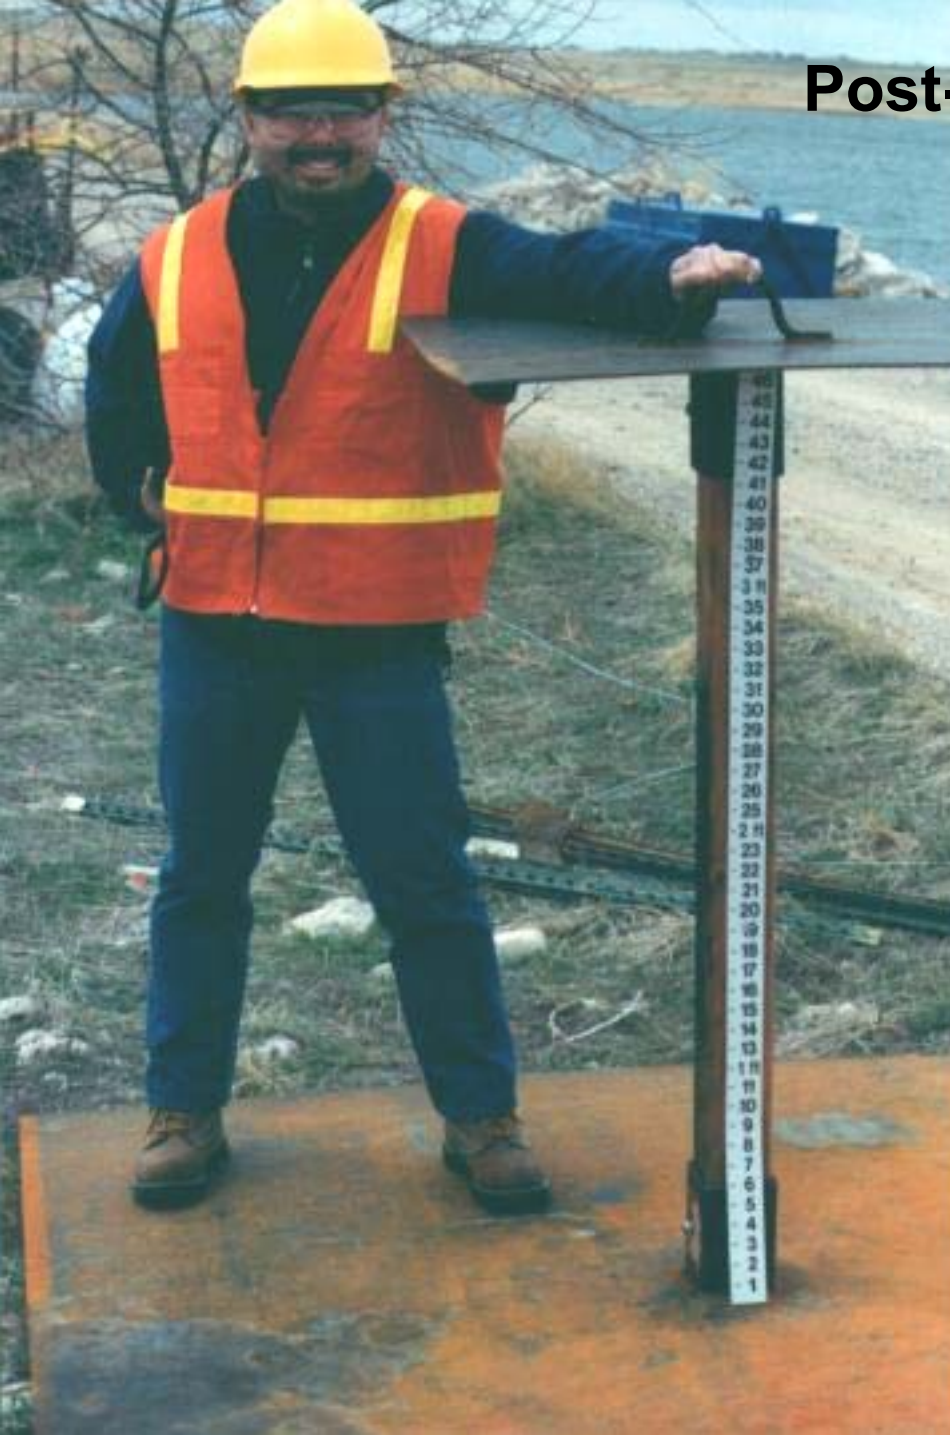
Post-Cap Placement Investigation 3 & 11 Months

- Bathymetry and settlement plates
- Cap coring
- Passive pore water collection
- Sediment traps
- Groundwater testing
- Wetland tissue and aerial coverage
- Invertebrate infauna recolonization
- Toxicity testing
- Bird surveys

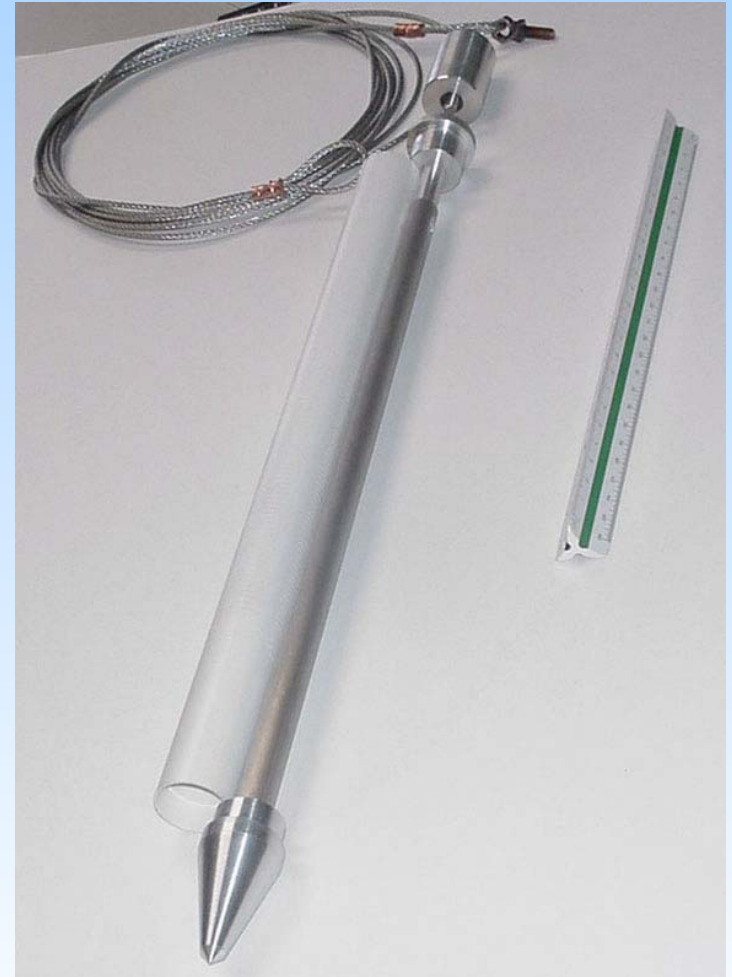
Passive Pore Water Collectors

- 18-inch stainless steel/PVC samplers
- Osmotic bag used for collection
- Slowly equilibrates with surrounding pore water

Analyte	Units	Model	SLIB-02		SLIB-04	
		Results	Baseline	11 Month	Baseline	11 Month
Benzene	ug/L	46.4	24	0.2	18	1
Total Xylene (Calculated)	ug/L	198.3	139	< 0.6	75	< 0.6
Naphthalene	ug/L	34.2	110	< 0.5	54	< 0.5
Chromium	mg/L	0.0305	1.17	< 0.01	0.568	< 0.01
Lead	mg/L	0.0032	0.19	< 0.001	0.18	< 0.001
Cap Thickness	inches			21 inches		30 inches

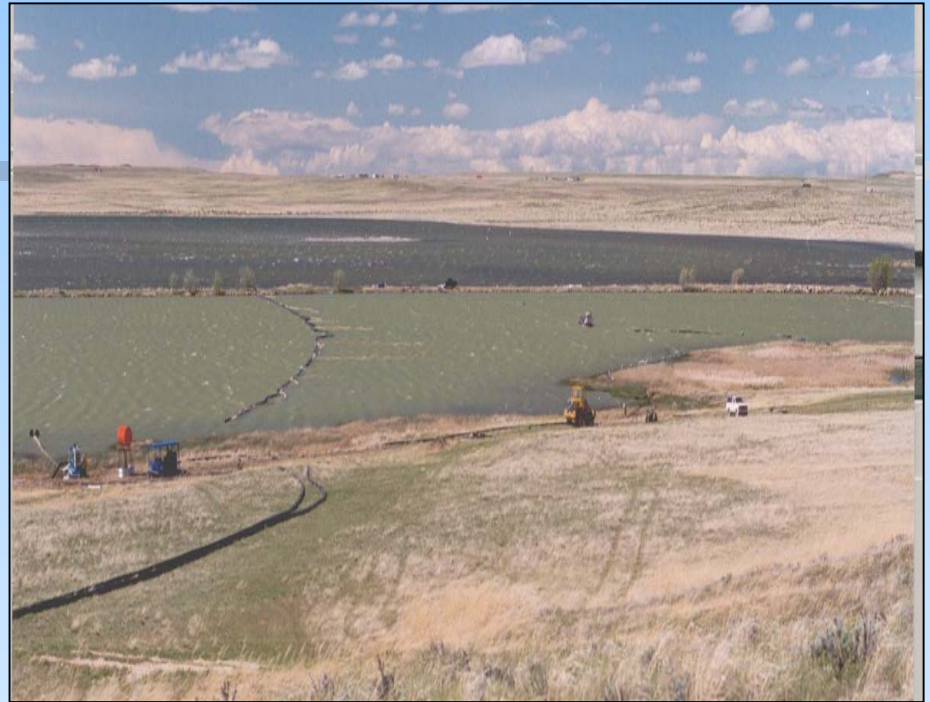
Main Lake

Weight-of-evidence approach using 1) EPA PAH narcosis model, 2) toxicity tests, and 3) site conditions resulted in “No Further Action” status for the lake.

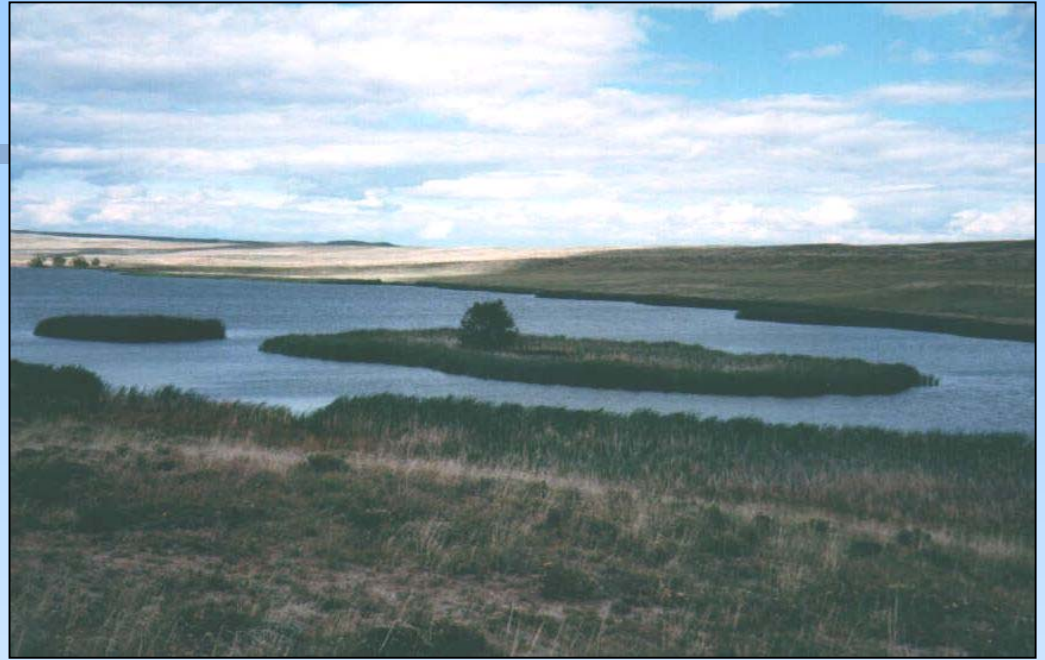
Remediation Plans

Although the capping study showed adequate stability and protection of ecological receptors (no porewater flux), the client decided on dry excavation of Inlet Basin to eliminate long-term liability.
